Community Resource Assessment & Ground Validation of the Proposed Sasmuan Critical Habitat & Ecotourism

DENR PENRO Pampanga
Biodiversity Management Bureau
Local Government Unit of Sasmuan
2015

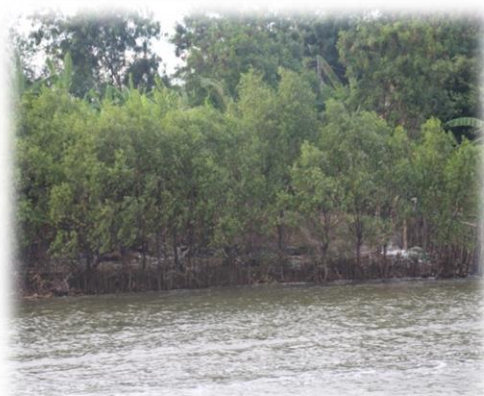
An approximate total of 21.6 hectares of remaining mangroves was assessed in the five (5) coastal barangays of Samuan Pampanga namely: Malusac (0.3 hectare), Batang 1st (3.5 hectares), Batang 2nd (14.1 hectares which include the islet with 11 hectares), Mabuanbuan (3.1 hectares) and Sebitanan (0.45 hectare). Most of

the mangrove areas are classified as riverine types of mangrove with sandy to muddy substratum. The sparsely vegetated riverine types of mangroves were observed at the riverbank of Pasac-Macabebe River low course extending up to the upstream of the river geographically located within 120°37'36.5" longitude and 14°54'29.7" latitude (Table 1).

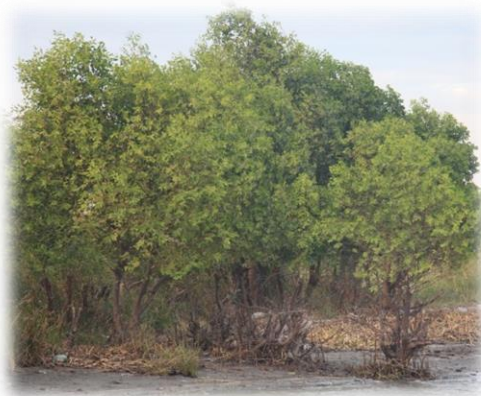
On the other hand, vigorously growing overwashed mangroves are observed at the river delta of Barangay Batang 2nd. This is a small island of mangroves

located at the intertidal zone of the Pasac-Macabebe River and Manila Bay. This area is observed frequently washed by tides with muddy to clay loam substrates dominated by *Sonneratia alba* (Pagatpat). This site is also within the proposed critical habitat and eco-tourism area of

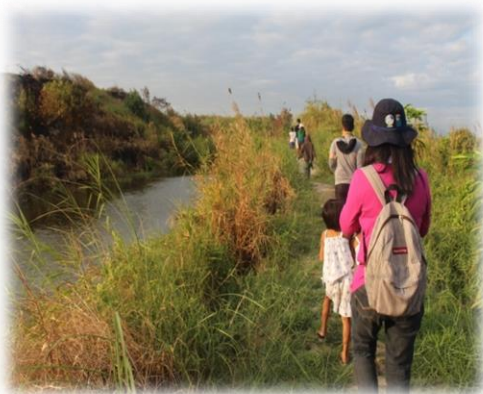
The conduct of ocular survey confirmed the presence of true mangroves and mangrove associates in Pasac - Macabebe River. A total of six (6) true mangrove species represented by *Sonneratia alba* (Pagatpat), *Rhizophora*

Dominant mangrove specie observed is represented by *Sonneratia alba* (Pagatpat) inhabited the riverbanks from the low course extending up to the upstream and alluvial island formed in the delta of the Pasac Macabebe River. Mangrove associates species recorded in the area include *Morinda citrifolia* (Bangkoro), *Terminalia catappa* (Talisay) *Sesuvium portulacastrum* (Dampalit), *Acanthus ilicifolius* (Diluario) and *Acrostichum aureum* (Lagolo). (Picture deluario, dampalit)

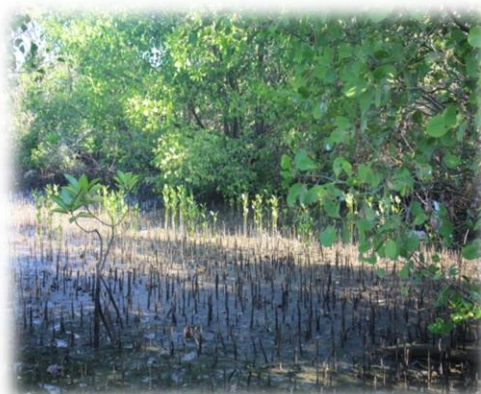
Furthermore, numerous regenerations of *Sonneratia alba* (Pagatpat) are observed vigorously growing at mangroves islands of Sasmuan Critical Habitat and Ecotourism Area. These seedlings can be uprooted and placed in polybags for further growth under nursery condition to be used for future restoration/planting activity.

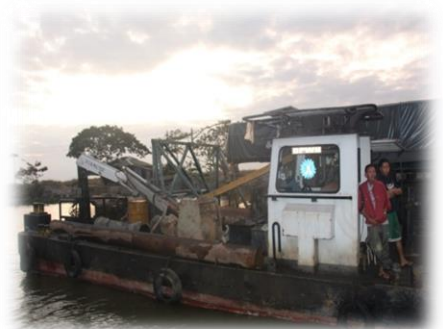
Resource mapping in the area also recorded the locations of the on-going dredging activities conducted in the area. As per interview conducted with the the Pampanga DPWH there are four (4) active dredging equipment in the area. Actual site visits recorded four (4) operational dredging equipment as follows:

Due to the heavy silatation in the area approximately 300 cubic meters of sediments were collected every day. The sediments are place at the (5) spoil sites map located at Brgys. Malusac, Sebetinan, Batang 1st and Batang 2nd.

Dredging can create disturbance to aquatic ecosystem. The suspended sediment load and turbidity of a river are increased during the removal of bed or bank material, it will also affect spawning fish, juvenile fish as well as the micro and macro benthic species which inhabited the substrate. However, interview revealed that this activity is beneficial to the community.

1. Conduct inventory and profiling of aquatic fauna to identify and assess the condition of aquatic species present in the area.
2. Implementation of mitigation techniques must be applied to minimize the impacts of dredging works.
3. Application of environmentally safe dredging techniques to minimize the impact and disturbance to aquatic ecosystem

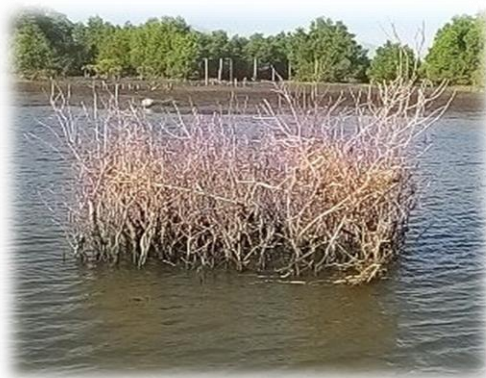
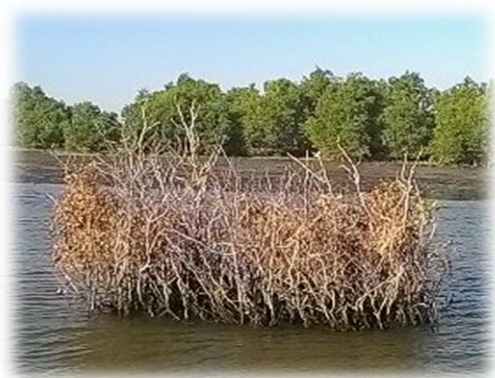
“BunBun”: Artificial Reef

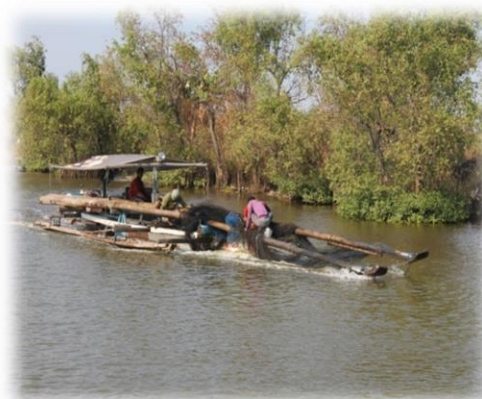
“Sudsud”: Small Adaptation of Trawlers

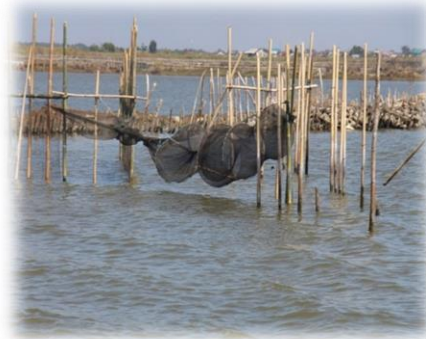
“Pasabal”: Portable Trap

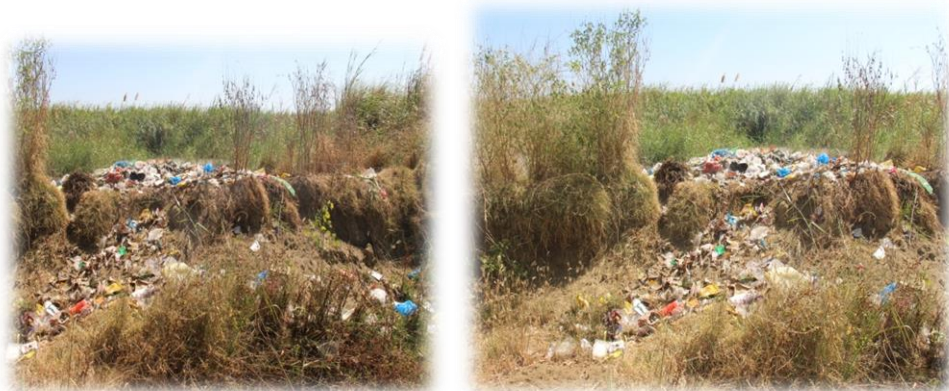
Most of the coastal barangays do not practice the RA 9003. Hence, there were open dumpsites observed during the ground validation.

Improper Solid Waste Disposal

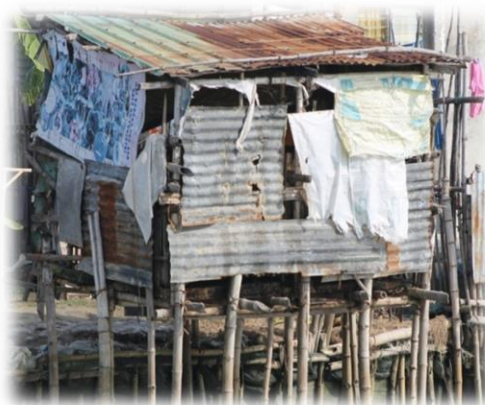
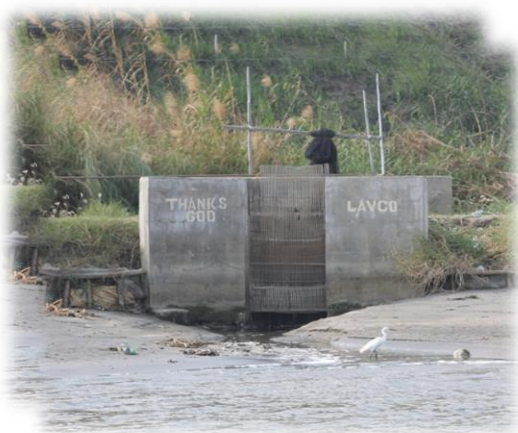
Improper waste disposal such as wastewater discharges from ponds and unsanitary toilets directly pollutes Pasac River. Both attributed to worsening of the water quality of the river and resulted to the decline in biodiversity in the area and affects human health.

a. Wastewater

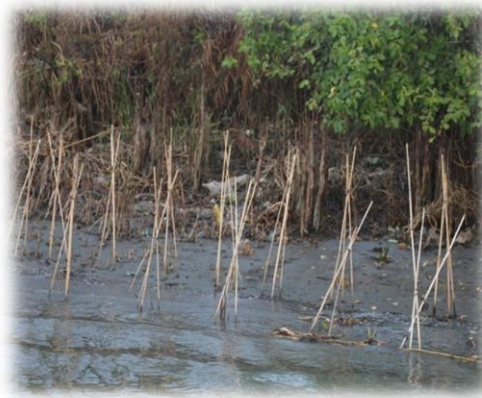
Unsupervised planting activity was also observed in the site. Clustered planted Bakauan propagules with 0.25m x 0.25 m was transected inside the Critical Habitat, accordingly this planting activity was conducted by

Angeles University Foundation. This strategy is noticeably affecting the growth and development of the propagules in the site. This strategy is deemed inappropriate and unnecessary because the propagules will just compete for space and limited

8. Proper site selection and species site matching following the zonation pattern of the mangroves and mudflats;
9. The application of aquasilviculture technology to enhance mangrove rehabilitation;
10. Periodic monitoring of the status and condition of the mangrove areas; and
11. Conduct of regular water quality monitoring of Pasac River.

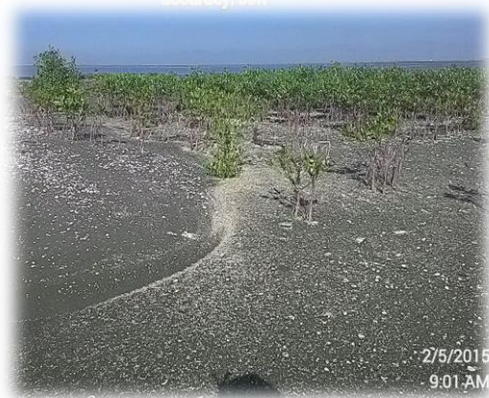
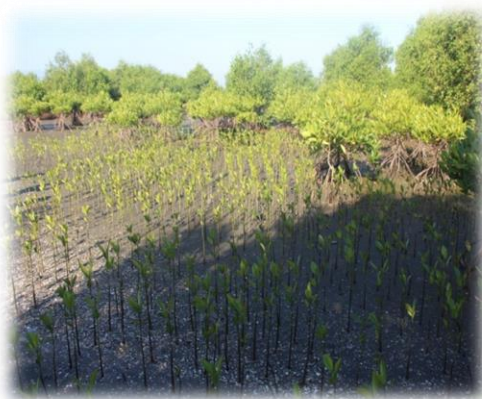
Furthermore, inappropriate planting methods were also observed along the upstream riverbanks of Pasak-Macabebe River. The specie of Bakauan propagule were planted at the

open gaps of the homogenous Pagatpat communities. Bamboo stakes was also used as a tree guard instead of peg to avoid the uprooting propagules. Accordingly, this planting activity was conducted by Pampanga Agricultural College in

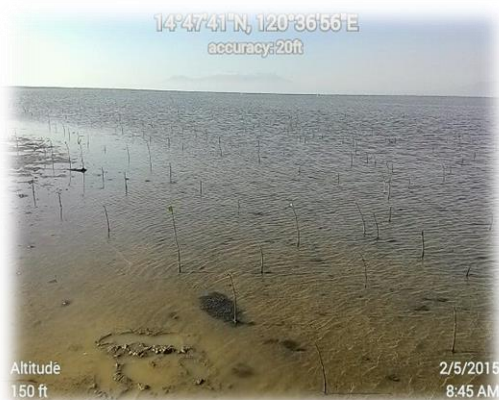
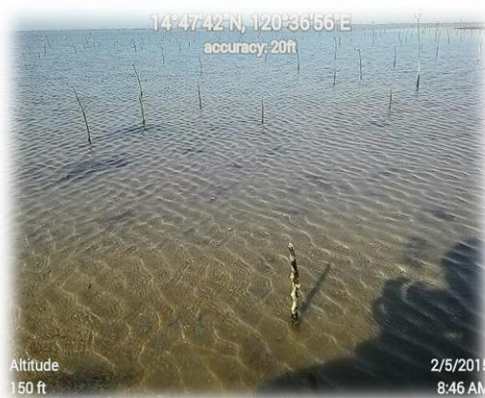
Un-assessed and un-map rehabilitation activity was observed in this area through the National Greening Program (NGP) in coordination with the Barangay. Based from the records gathered

from the CENRO – Pampanga, a total of 292,000 of Bakauan propagules and pagatpat seedling were planted in this area in CY 2013 having an area of 146 hectares. Actual validation observed that most of the planted species in the area are Bakauan propagules, only few Pagatpat species were sighted during the assessment. High mortality rate of these planted mangroves are also noted in the area.

Mangrove species suitability and improper site selection are the major factors that may contribute for the failure of this activity. The planting site was conducted in an open mudflats areas wherein there is no indicators of mangroves grown making it unsuitable for mangrove reforestation. It is also exposed to storm surges, waves and tidal currents during monsoon season which may affects the growth and survival of the planted mangroves in the area. In addition, natural sand shifting activity was also observed in the area.
